Technical Update

Issue Number: TU228

Product Description: **SmartPilot S1 & S1G Course Computers, Corepacks & Systems**

Subject: **Fluxgate Compass Circuit Fault**

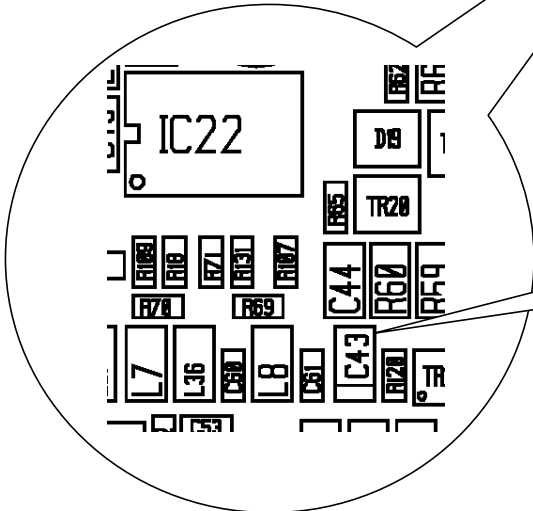
The fault is associated with the wrongly reverse placement of the fluxgate drive AC coupling capacitor C43. The fault does not affect all S1 Course Computers and is only triggered when the tolerance of the capacitor is at the limits of its value specification.

C43 Polarised Capacitor 2.2uF 6.3v
Wrongly Placed on PCB!

- Remove PCB from plastic casing
- Locate C43 Capacitor
- Unsolder & Remove from PCB
- Replace & re-solder in reverse
