Technical Update

Issue Number: TU228

Product Description: **SmartPilot S1 & S1G Course Computers, Corepacks & Systems**

Subject: **Fluxgate Compass Circuit Fault**

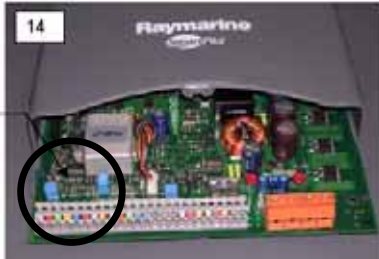
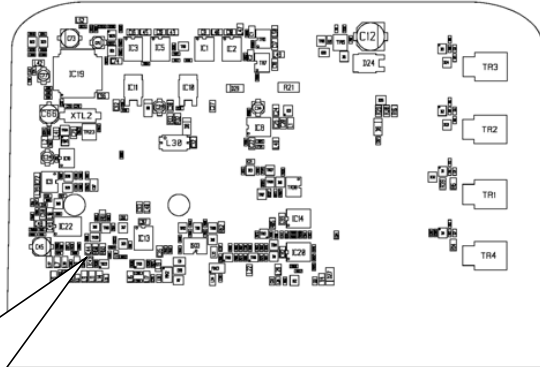
The fault is associated with the wrongly reverse placement of the fluxgate drive AC coupling capacitor C43. The fault does not affect all S1 Course Computers and is only triggered when the tolerance of the capacitor is at the limits of its value specification.

C43 Polarised Capacitor 2.2uF 6.3v
Wrongly Placed on PCB!

- Remove PCB from plastic casing
- Locate C43 Capacitor
- Unsolder & Remove from PCB
- Replace & re-solder in reverse
